Reduction of Non-Productive Time in Apparel Manufacturing: A Garment Factory Case

Citation: Rimsa T., Shafiullah K. Reduction of Non-Productive Time in Apparel Manufacturing: A Garment Factory Case, *Int.J.Tex.Engg.Mgt.*, Vol.1(1) 2025: 29-35, DOI: https://doi.org/10.63261/ijtem116

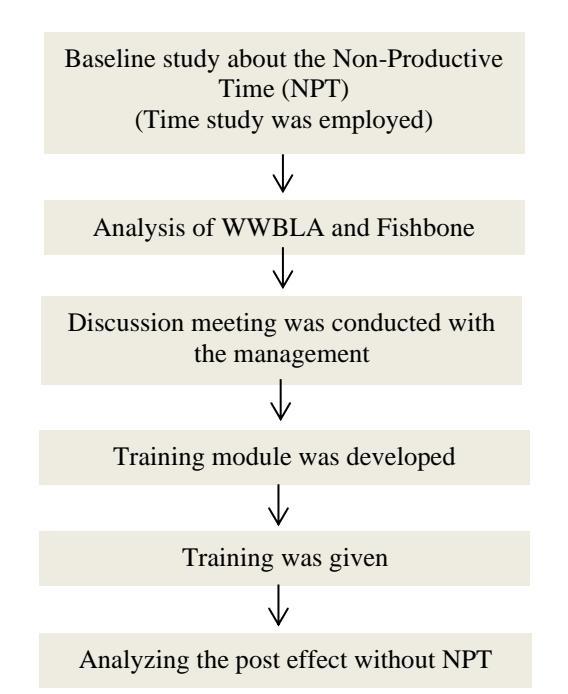
Figure 1. Study framework for the reduction of nonproductive time (NPT) of a garment unit under this study.

A fishbone diagram is a useful tool to determine the possible causes for a problem, but it cannot identify root causes. It shows the causes of any problem in a more structured approach than other brainstorming tools [20]. This study used time study to find out the baseline of the current status of the production process of an apparel factory in Bangladesh. Time study identified non-productive time (NPT) of the cutting and sewing section engaged for three different apparel styles. WWBLA and fishbone techniques were employed to find the phenomenon and their root cause analysis. Discussion was necessary with management of the factory to share the results obtained from the study. A training module was developed and conducted for the operators of the respective session. Post-effect was finally analyzed without NPT. The overview of the study framework is visualized in Figure 1.

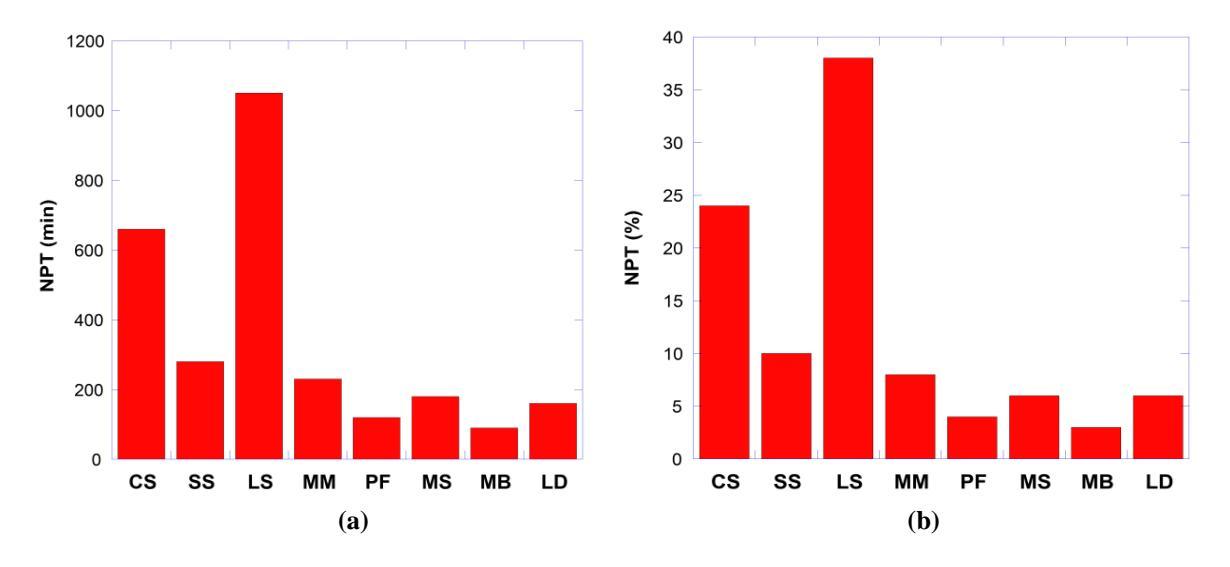
Figure 2. Cause-wise Non-productive time (NPT): (a) total NPT in minutes over two weeks of study; (b) percentage-wise NPT. CS: cutting section, SS: sewing section, LS: line settings, MM: machine maintenance, PF: power failure, MS: material shortage, MB: machine breakdown, and LD: labor delay.

The cutting section and sewing section had some minor stoppage and idling, which are denoted as CS and SS. The minor stoppages (CS and SS) mostly include some minor delay in cutting sections, thread breakages in sewing, and other avoidable causes. It can be seen from Figure 2 that minor stoppages in the cutting section were higher than those in the sewing section.

About 34% of the losses were due to minor losses, of which 24% were for the cutting section (CS) and 10% were for the sewing section (SS). The highest losses were found to be 37.91% in the sewing section due to the line settings (LS) for various adjustments during the production time and especially at the initial settings of the line before the introduction of the style to be manufactured. When a new style needs to be introduced for the first time in a sewing line, LS consumes a lot of time. For a line setting, internal and external activities are essential. These activities cannot be fully eliminated but can be minimized or reduced to a minimum level.

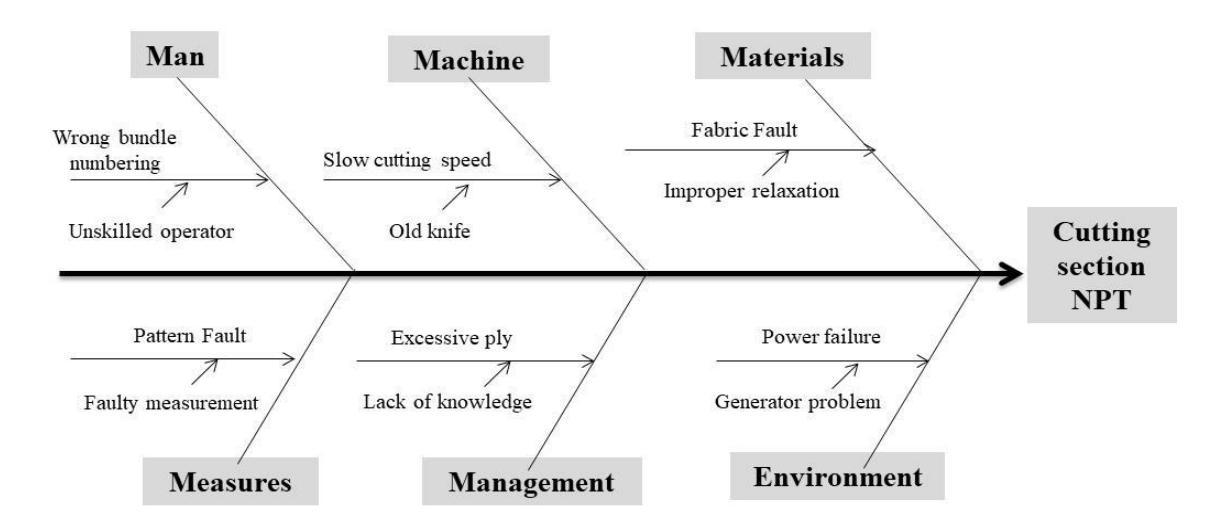
Figure 3. Fishbone diagram for total minor stoppage type NPT in the cutting section

The fishbone diagram is presented in Figure 3, which is constructed based on the WWBLA for the total NPT of the cutting section. The reasons are grouped by man, machine, materials, measures, management, and environment.

From the fishbone diagram shown in Figure 3, it can be seen that wrong bundle numbering occurred due to the unskilled operator. Cutting speed was slow because of the old knife. A fabric fault was observed due to improper relaxation. Pattern faults happened as a result of faulty measurement. Excessive ply was due to the

lack of know-how. The power failure was due to the breakdown of the power generator. Proper countermeasures were taken to fix the problem by having a discussion with the management of the apparel factory.

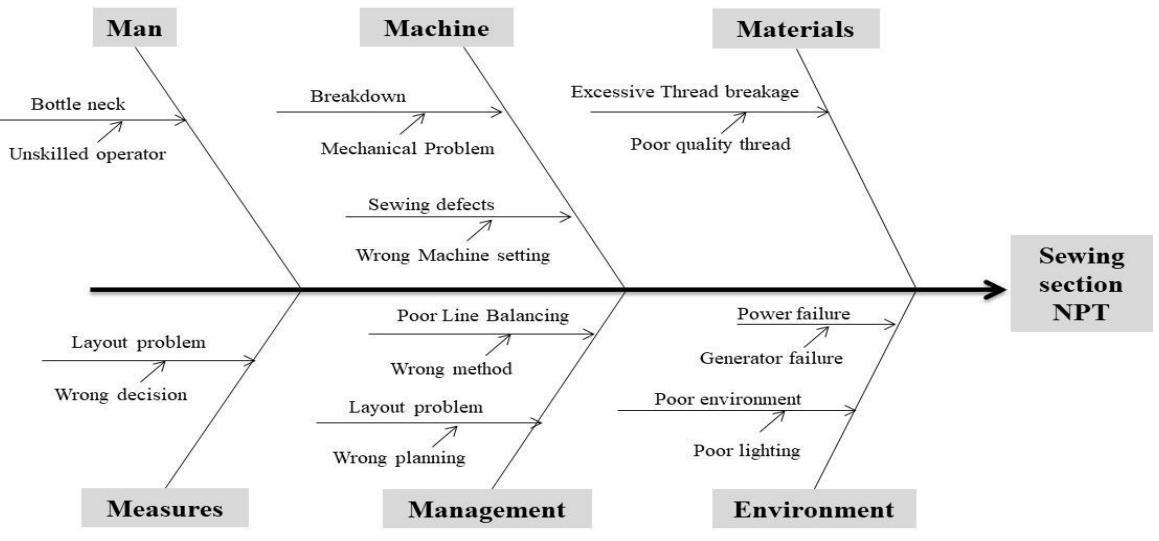
Figure 4. Fishbone diagram for total minor stoppage type NPT in the sewing section

Table 4 illustrates the WWBLA worksheet for the total NPT of the sewing section. The countermeasures were applied according to the WWBLA worksheet. The fishbone diagram is displayed in Figure 4, which is constructed based on the WWBLA for the total NPT of the sewing section. The reasons are grouped based on the man, machine, materials, measures, management, and environment. The bottleneck happened due to the unskilled operator setting the line supervisor. Poor line balancing and layout were due to the wrong planning and method employed for that. Excessive end breakage was due to the poor thread quality. Power failure and poor lighting also affected the NPT of the sewing section. Necessary countermeasures were taken to minimize the phenomenon. After taking necessary action against each phenomenon, the performance of the cutting and sewing section was measured in terms of target production per hour and standard minute value (SMV). Table 5 and Figure 5 show the changes in SMV without NPT and with NPT in the sewing section. The SMV increased 7.53%, 7.19%, and 8.42% for T-shirts, polo shirts, and hoodies, respectively. Again, this column chart of Figure 6 displays the target and actual production for three different styles, both with NPT and without NPT. It shows that the target for the t-shirt increased to 10 pieces when NPT is excluded, while for the polo shirt it goes up to 8 pieces, and for the hoodie, it reaches 12 pieces (Table 6). The actual production increased 6.67%, 7.27%, and 10% for T-shirts, polo shirts, and hoodies, respectively. The more improvement in the case of the hoodie is attributed to the skills of the operator. Though the T-shirt is the basic garment and comparatively less complex operations are in it, due to some unknown reason the improvement was less than for other garments.

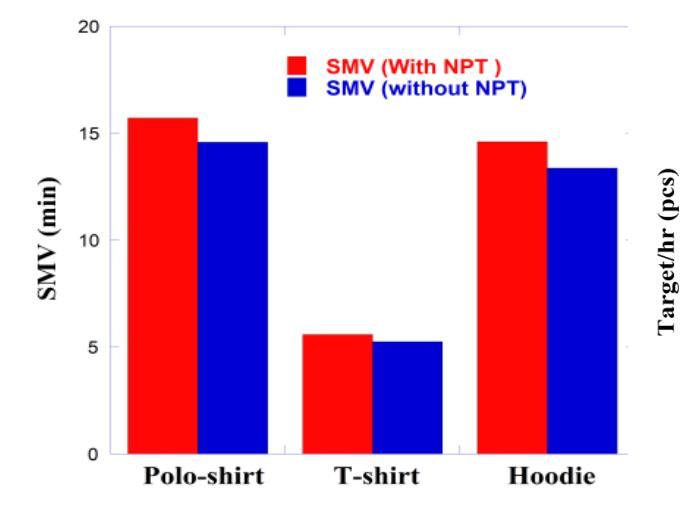
Figure 5. Reduction of SMV of the sewing section with NPT and without NPT for three different styles
